Nuclear  
Decommissioning:  
La Crosse BWR

DESCRIPTION  
Provide Access to  
the Boiling Water  
Reactor for  
Segmentation and  
Disposal

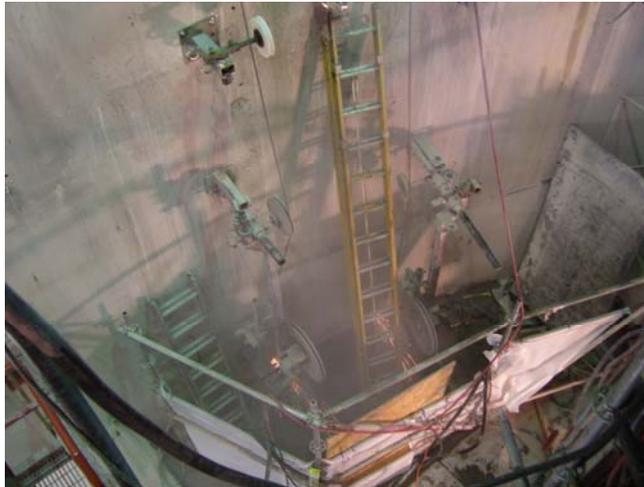
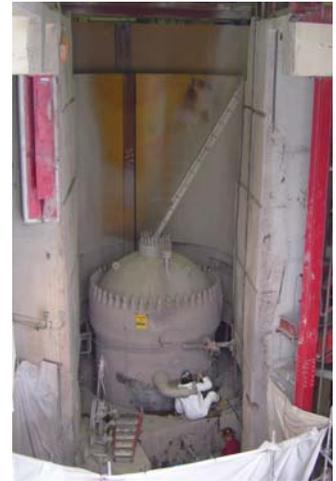
**SOLUTION:** We approached the project in three phases. First, we cut a 40' x 60' opening in the side of the reactor containment structure which consisted of 9" thick concrete and a 1" thick carbon steel liner. The second phase was cutting an opening in the 6'-9' thick bioshield wall. The outer half of the bioshield was regular concrete, the inner half was high density concrete, and they were separated with corrugated 3/8" thick carbon steel. We cut this wall into 23 pieces weighing up to 30,000 lbs. each. For removal, we designed special rigging attachments which held the pieces together while they were lifted out.

This gave us access to the reactor vessel where our diamond wire saws began segmenting the appurtenances from the reactor so it would fit into its storage canister. This required cutting 10 nozzles, 29 stainless steel control rod drive tubes, and 12 other welded attachments. To keep the cuts within tolerance, we set up pulleys and moved them constantly to keep the wire tracking on the rounded bottom of the vessel.
